4. TITLE (and Subtitle) Phase I Dam Inspection Report National Dam Safety Program Glen Leonard Dam (MO 30428) Jefferson County, Missouri		5. TYPE OF REPORT & PERIOD COVERED Final Report

GLEN LEONARD DAM  
JEFFERSON COUNTY, MISSOURI

MISSOURI INVENTORY NO. 30428

PHASE I INSPECTION REPORT  
NATIONAL DAM SAFETY PROGRAM

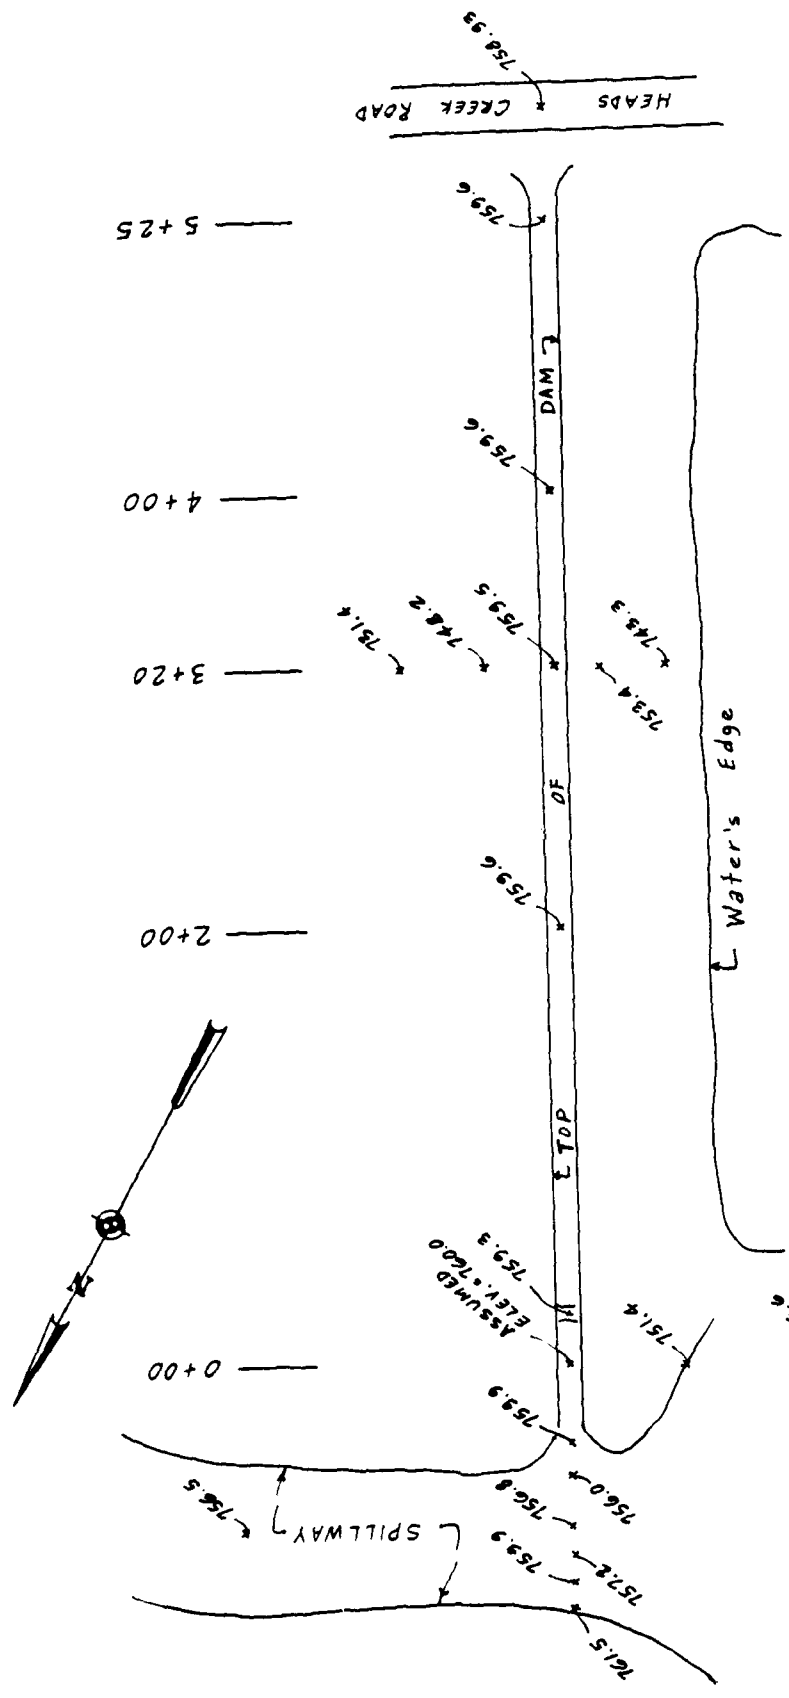
b. Dam. The dam has a narrow crest (14 + feet) and a height estimated at 29 feet (see PLATES 3 and 4). An embankment cross section is shown on PLATE 4. The slopes indicated are considered typical of the slopes on the entire embankment. The upstream and downstream slopes and spillway and exit channel are heavily covered with trees, brush and grass which would be detrimental to spillway flows. (See photographs 4, 5 and 6.) The spillway channel runs for about 300 feet downstream from the dam on a very small slope, then tapers off into the hills on the left of the old streambed.

(2) Level the dam crest along the waterline traverse and in the small ditch traverse to the dam axis at approximately station 0+25 as shown on PLATE 3 and establish a grass cover.

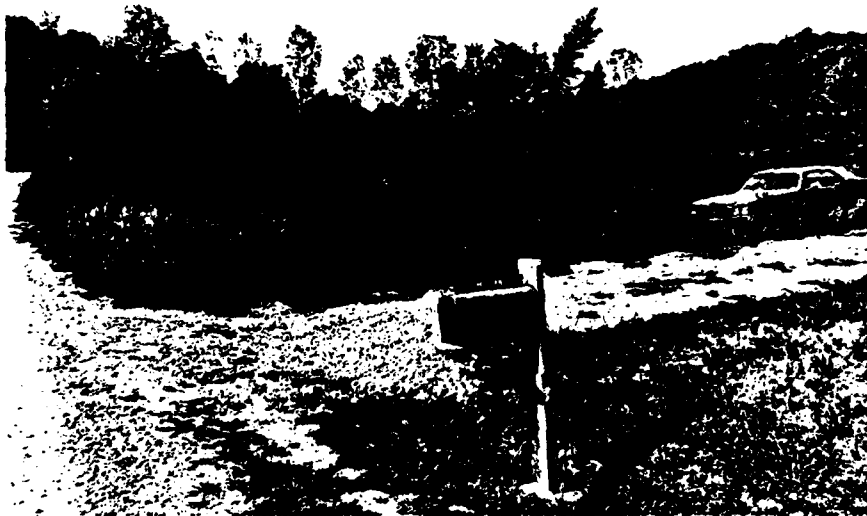
d. Downstream Seepage Area. The owner stated that when the water surface rises a few feet above the elevation on the day of the inspection (740.6+), seepage surfaces at a point about 300 feet downstream of the abutment. Hydrophytic growth indicated the probable presence of water consistent with the reported fact that seepage may have occurred at other times.

PHOTO 1 SEEPAGE AREA DOWNSTREAM OF  
DAM (Seepage Exits in Group of  
Willows at Left Foreground  
When Lake Level is Higher)
